Assessment on iVP Development Line Equipment Functionality Buy Off – [May 18 '2025](#)

- Performing Equipment Functionality Buyoff of Orthodyne Wire Bonder for TO 220 at Smart Option site in Ipoh ,Perak
 - Set up and Debug together with Mr Rhay - Smart Option Engineer

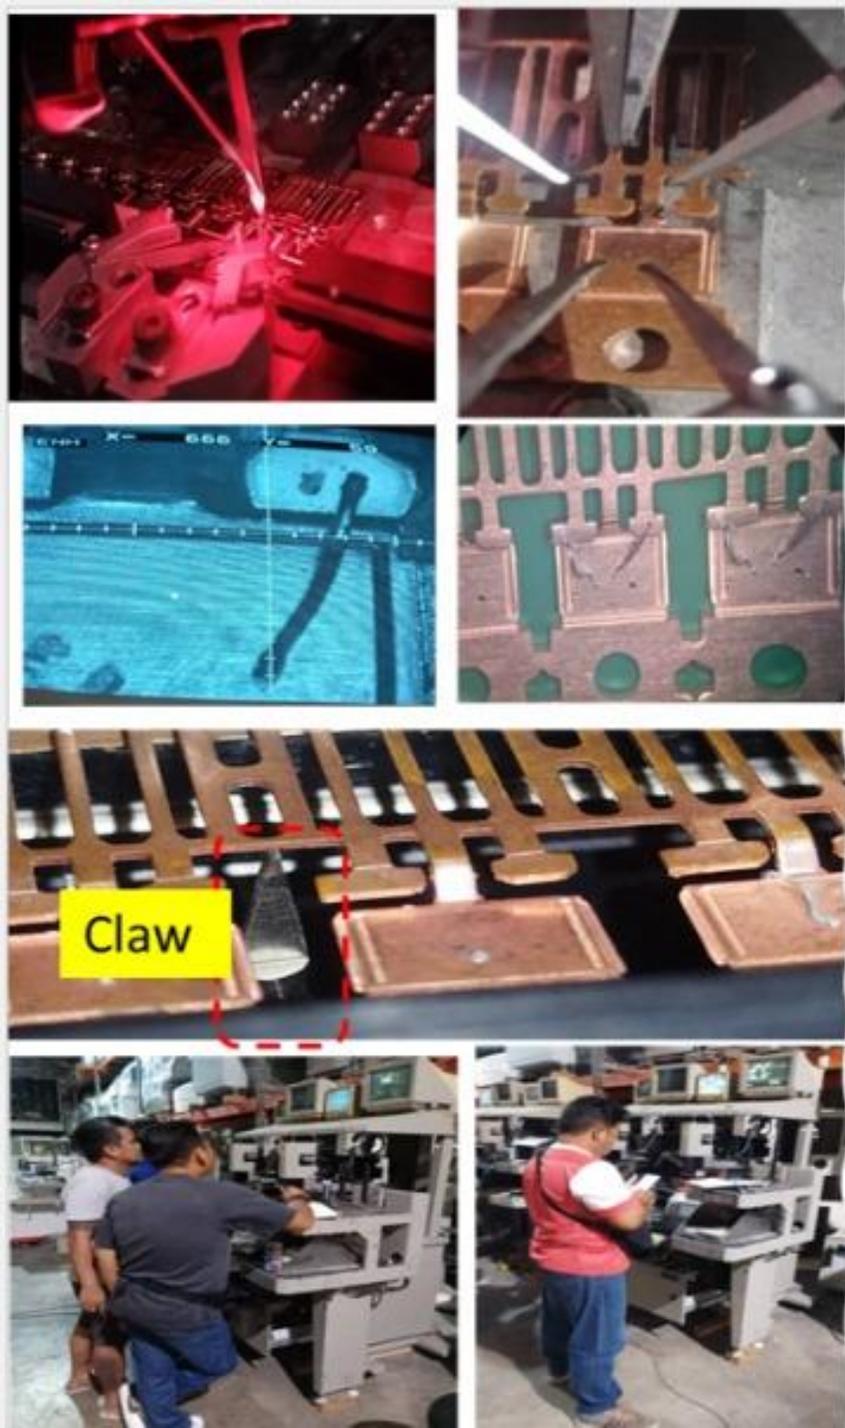
TO220 Orthodyne Aluminum Wire Bonding Machine

- **Lead Frame Indexing Adjustment**

- Indexing mechanism utilizes cam and claw pins
- Smart Option engineer Rhay resolved mis-step issue after 5 hours of fine-tuning

- **Aluminum Wire Bonding Capability**

- Supports wire size range from 5mil to 20mil
- Passed 3-stage buy-off using 10mil wire
- Proper finger clamping on each lead is critical for bonding quality

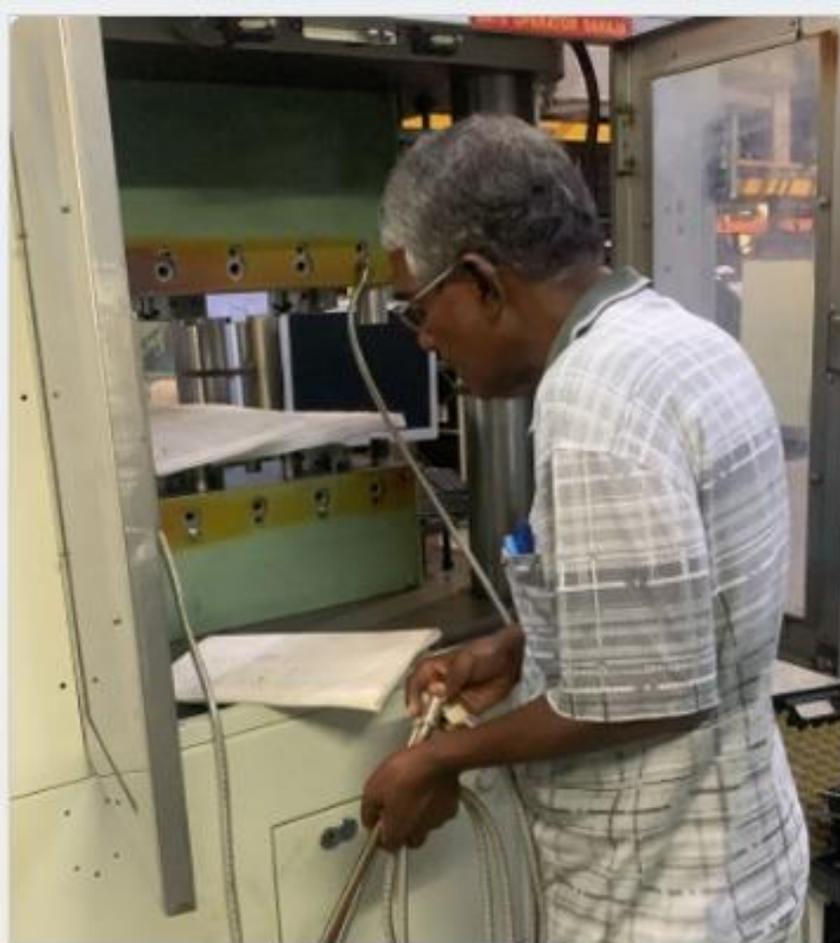
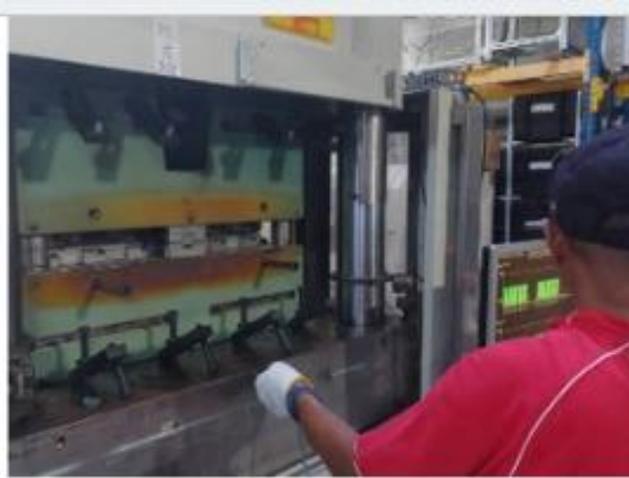
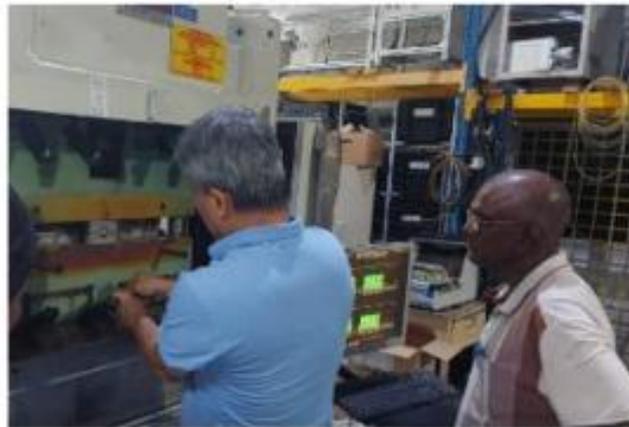
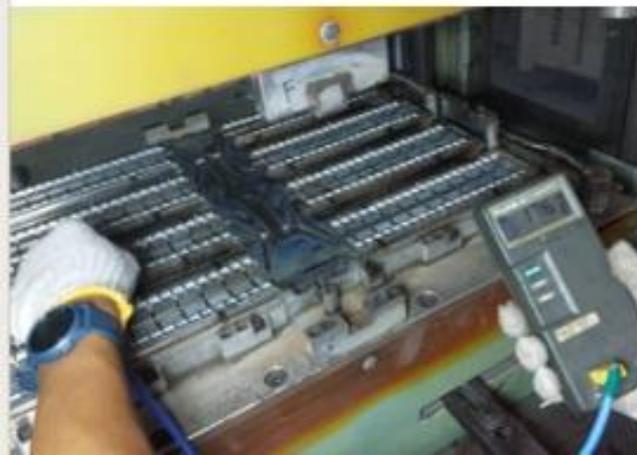
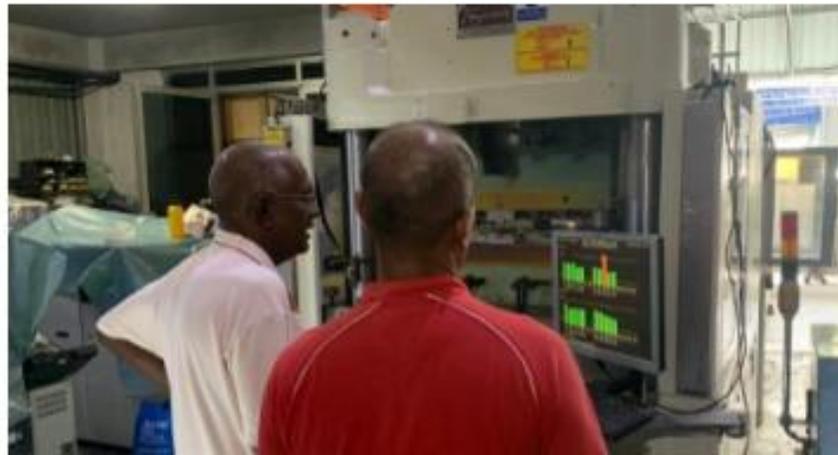
Fujiwa TO-220 Mold System Update

- **Pot & Plunger Alignment Verified**

- Ensured correct alignment of mold pot and plunger for TO-220 chassis to prevent flash and ensure uniform cavity filling.

- **Mold Temperature Stability Checked**

- Monitored mold temperature ($\sim 176^{\circ}\text{C}$) over multiple cycles; readings remain within $\pm 2^{\circ}\text{C}$ tolerance, confirming thermal consistency.

- **CPU Control Issue & Action Plan**

- Identified intermittent CPU fault on the mold press controller; Kenny to deploy Fastech engineer this week for diagnostics and firmware/hardware troubleshooting.

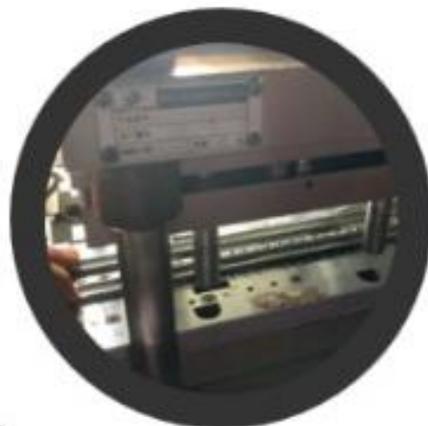
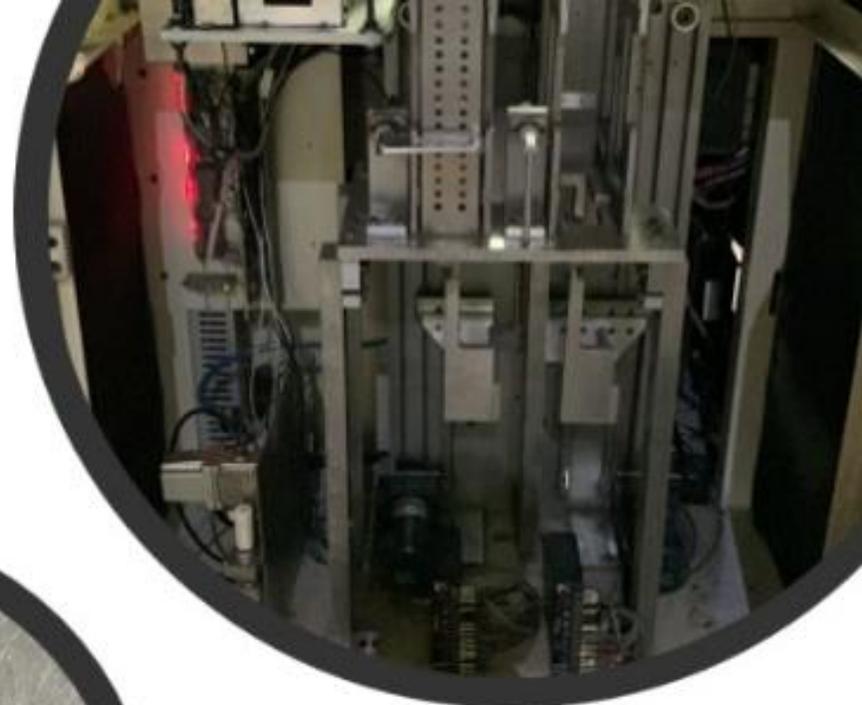
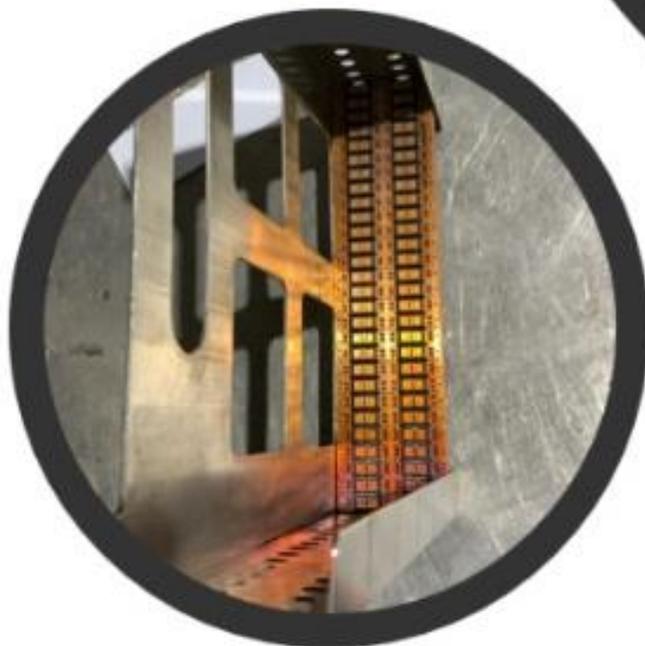
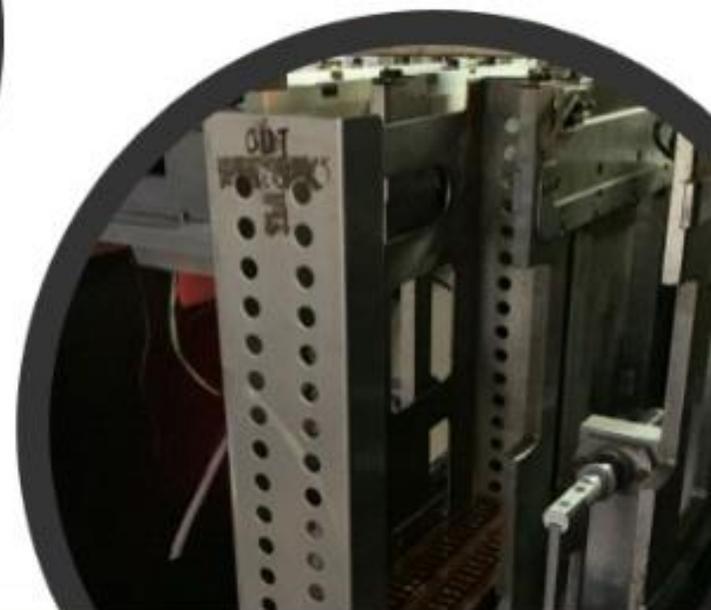
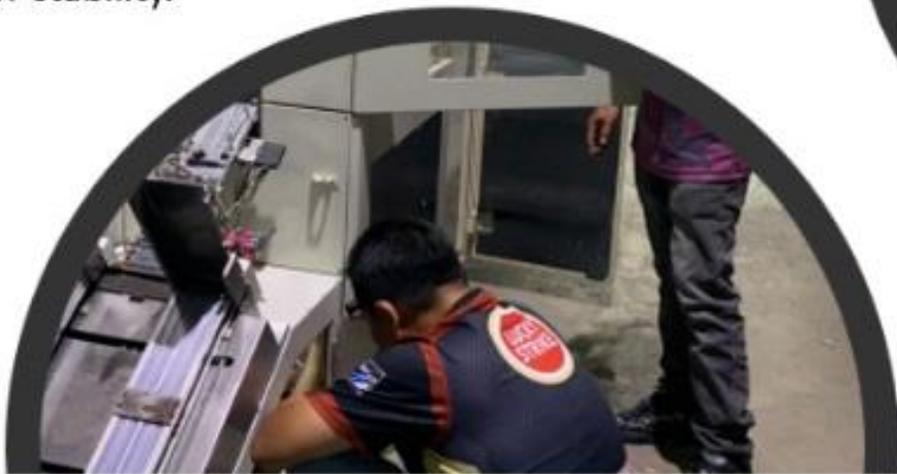
TO-252 Trim & Form Machine Setup Update

- **Punch & Die Verification Completed**
 - Punch check through stripper insert: Passed
 - High-speed singulation punch replaced and cutting die punch validated
- **Unloading & Elevator Instability Detected**
 - TO-252 unloading assembly not stable
- **Leadframe elevator operation shows irregular motion**
 - Corrective Action: PLC Assessment
 - Kenny to coordinate with the controls engineer to review and optimize the PLC program for unloading and elevator stability.
