Assessment on iVP Development Line Equipment Functionality Buy Off – [May 10 '2025](#)

ESEC Soft Solder Die Attach (TO-220) Equipment Update

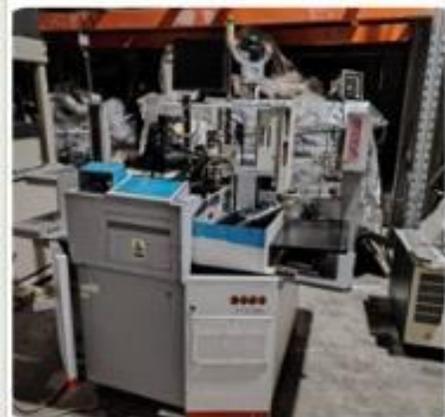
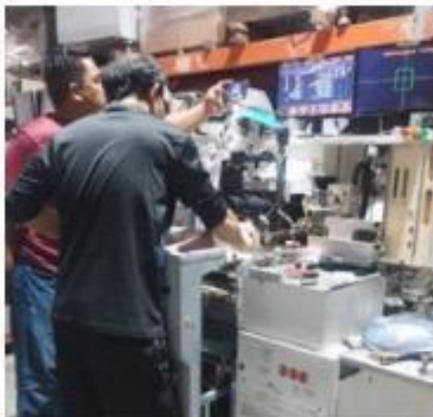
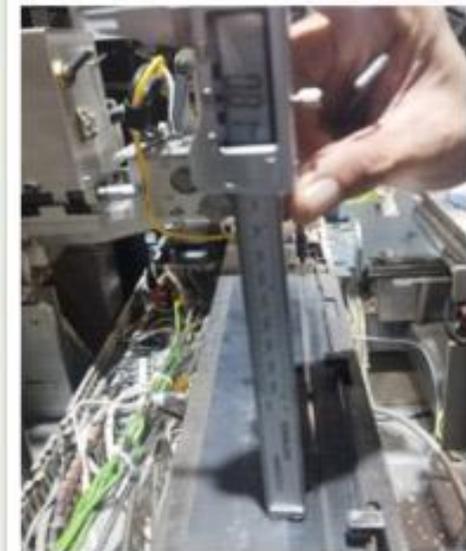
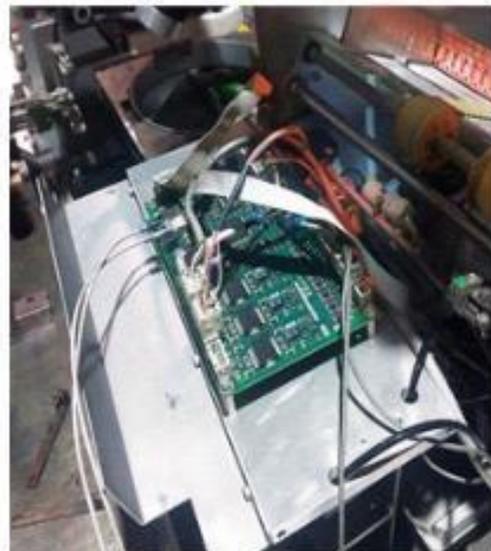
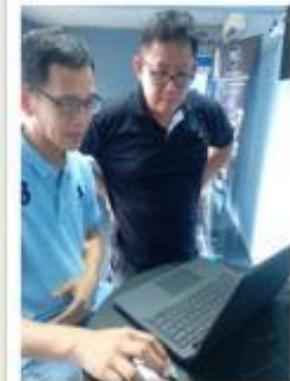
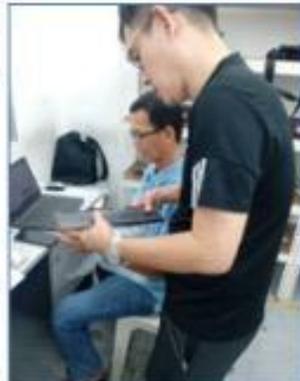
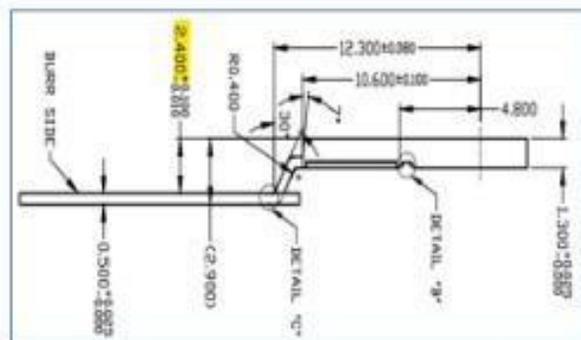
- Initial stage-2 buy-off passed; replacement heater board (after 2-month lead time) successfully powered up and tested and all functions nominal

- Existing machine track opening suited original lead-frame size; new TO-220 lead-frame is wider with a different downset, causing fit issues

- Engaging local milling houses to compare current track vs. latest LF dimensions and propose modification scope & cost by WW21
- Parallel discussion with Smart Option to finalize rework pricing and schedule

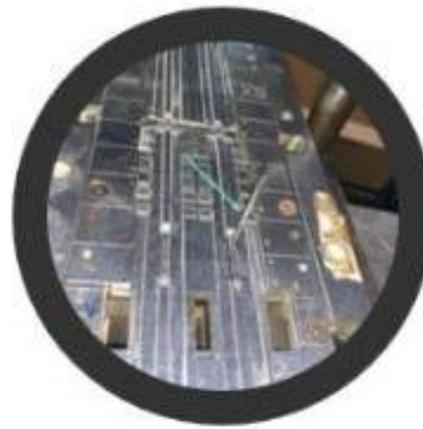
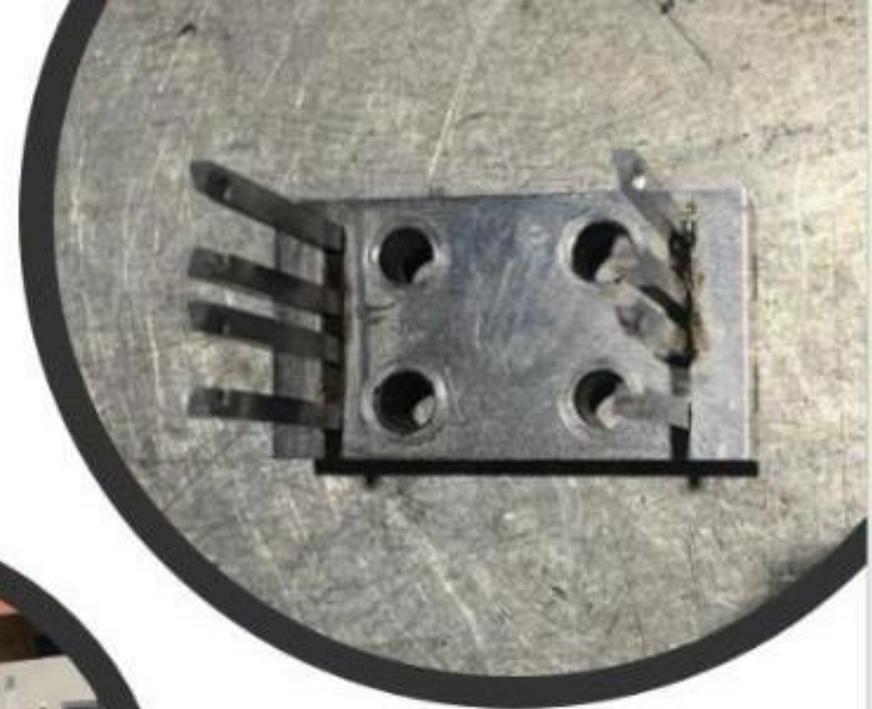
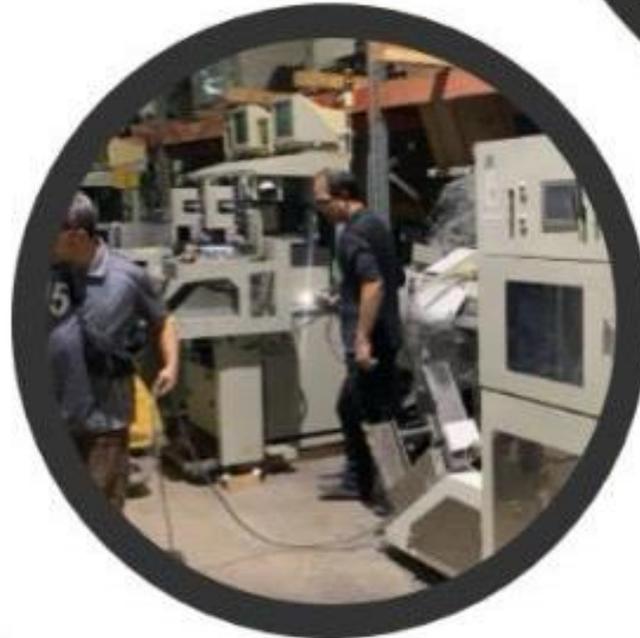
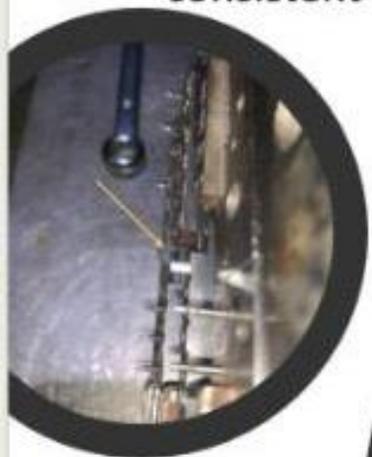
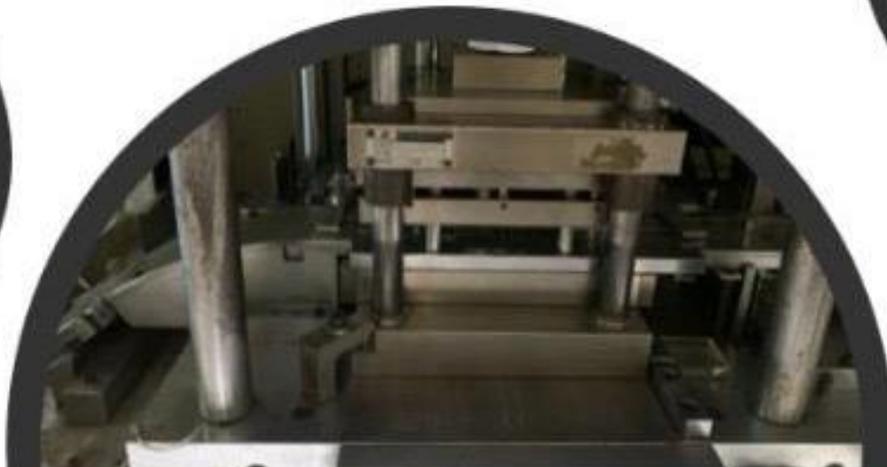
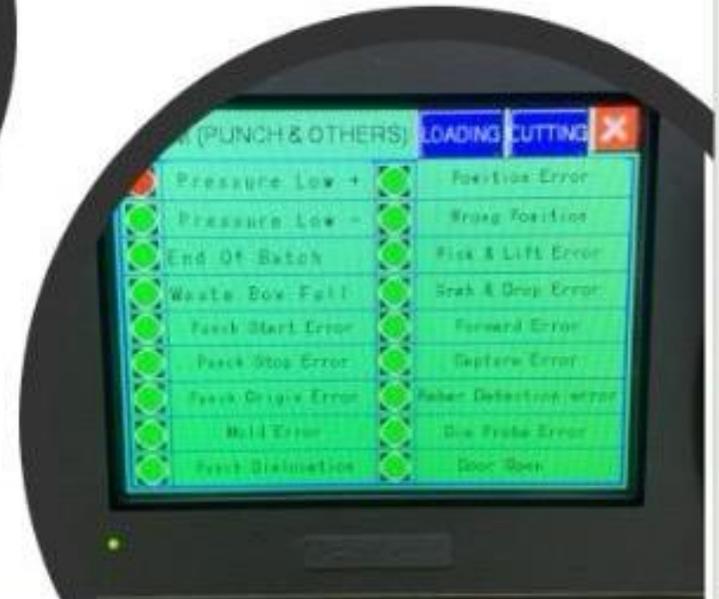
TO-252 Trim & Form Machine – Initial Setup

- Punch check through stripper insert – Passed
- HS singulation punch – Replaced
- Punch check through cutting die – In Progress

- Inconsistent incoming vacuum pressure detected during setup

- Investigate and stabilize vacuum supply to ensure consistent operation before full qualification

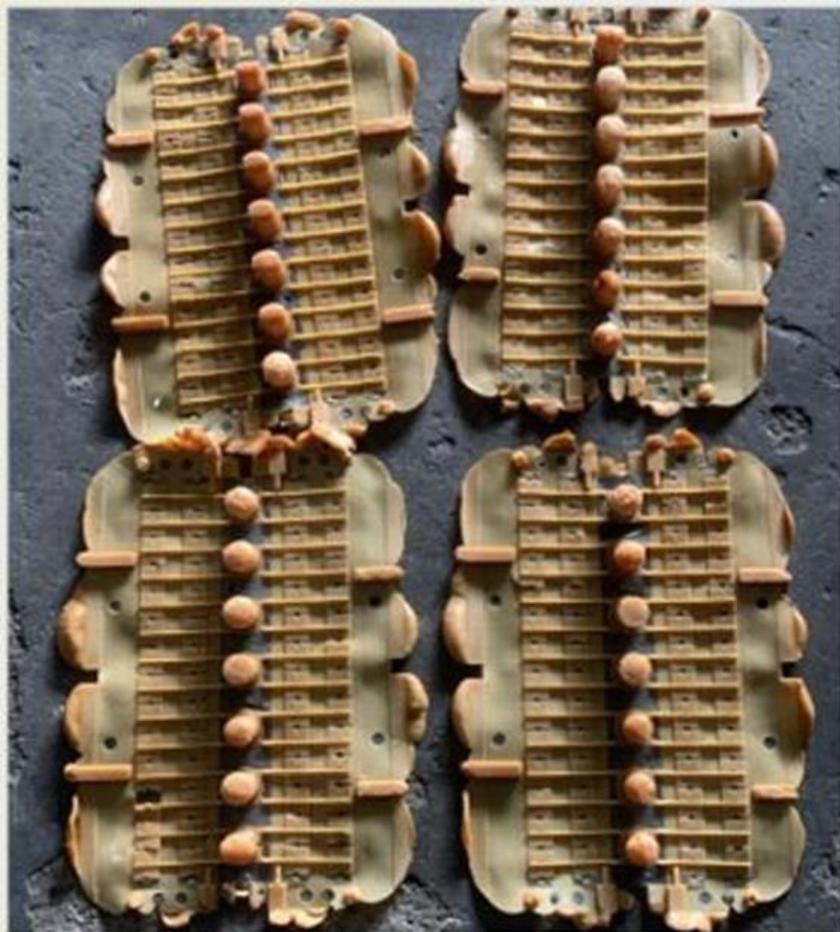
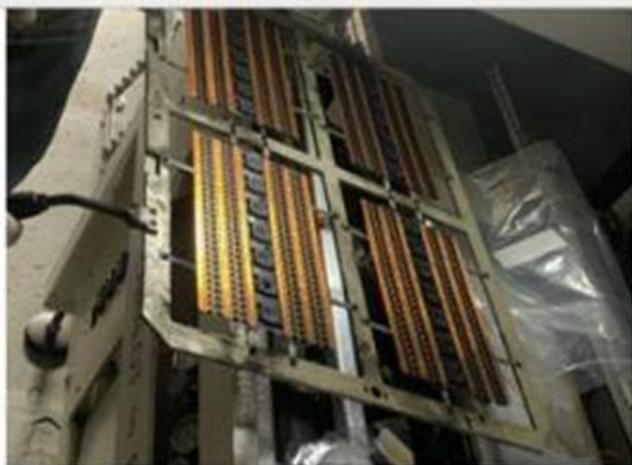
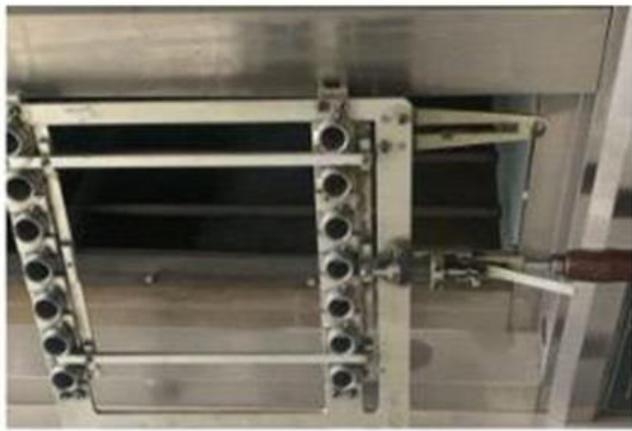
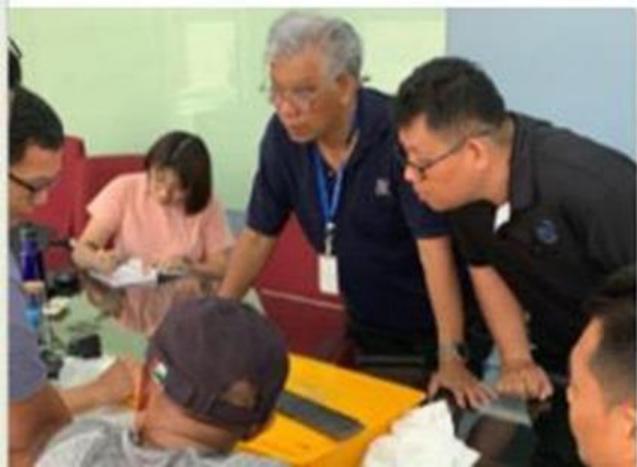
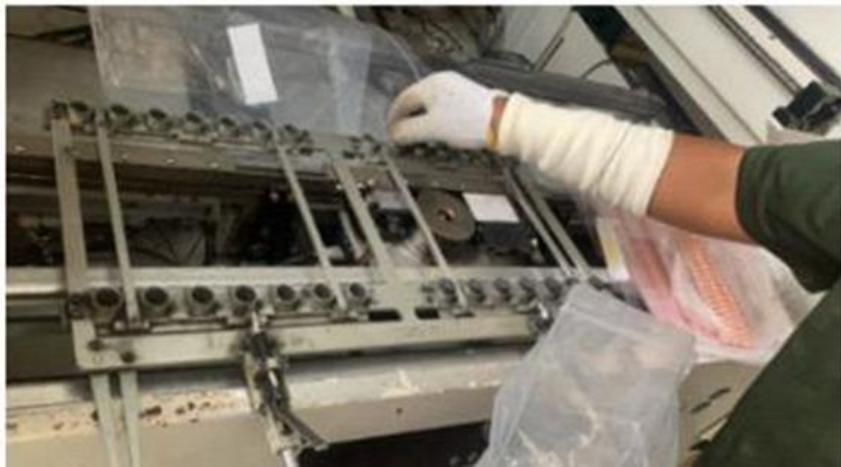
TO-252 Fujiwa 300T Conventional Mold – Setup & Debug Status

- Verified TO-252 molding short vs. machine compatibility
- Pallet loading used to assess mold condition

- Heavy flash detected at cull area

- Engaged with RC team tooling fabrication house to fine-tune the mold tool for flash elimination and improved molding quality

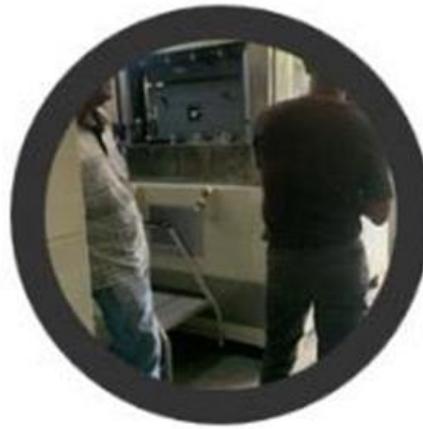
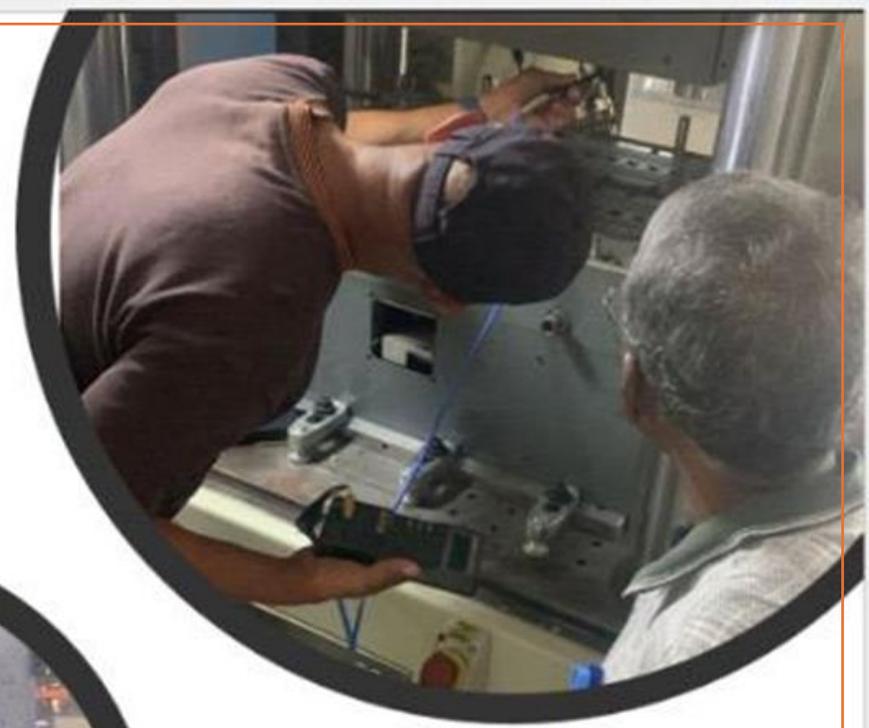
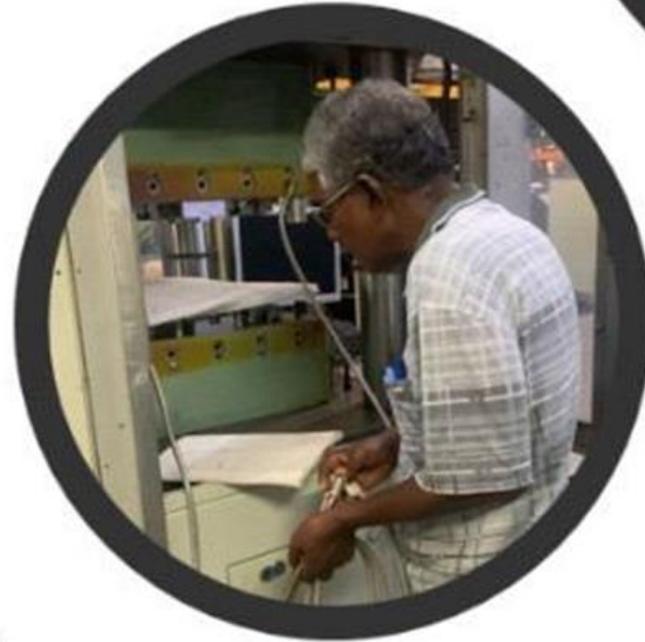
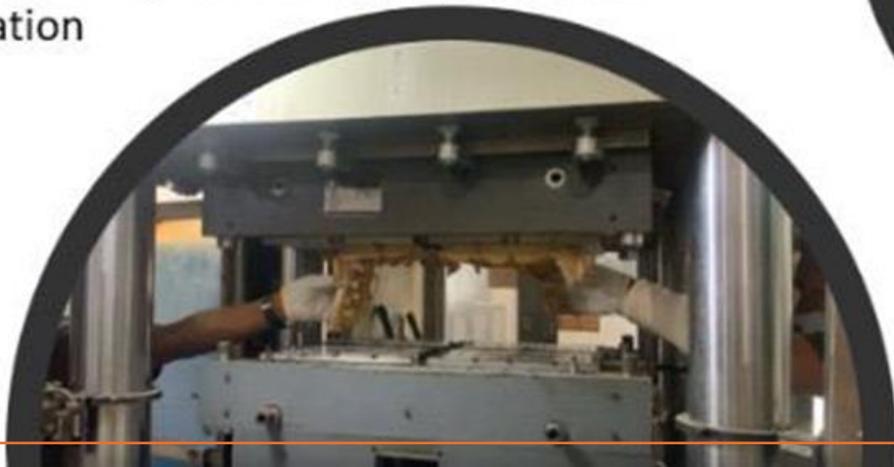
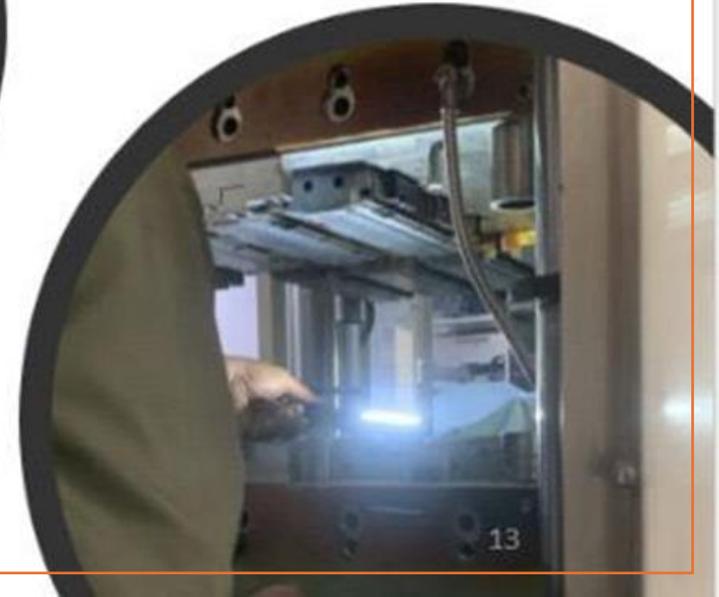
TO-220 Fujiwa 300T Conventional Mold – Setup & Verification

- **Heater Installation Progress**
 - Top & bottom heaters successfully installed on mold machine
- **Next Assembly Steps**
 - Reinstallation of top & bottom cull block, pot, and plunger planned once heater setup is completed
- **Verification Plan**
 - Conducting mold dummy short run to validate lead frame design before mold parameter optimization
